FIELD INVESTIGATION PHOTOGRAPH ALBUM

**OPERABLE UNIT NO. 7
(SITES 1, 28 AND 30)**

**MARINE CORPS BASE, CAMP LEJEUNE
NORTH CAROLINA**

JULY 29, 1994

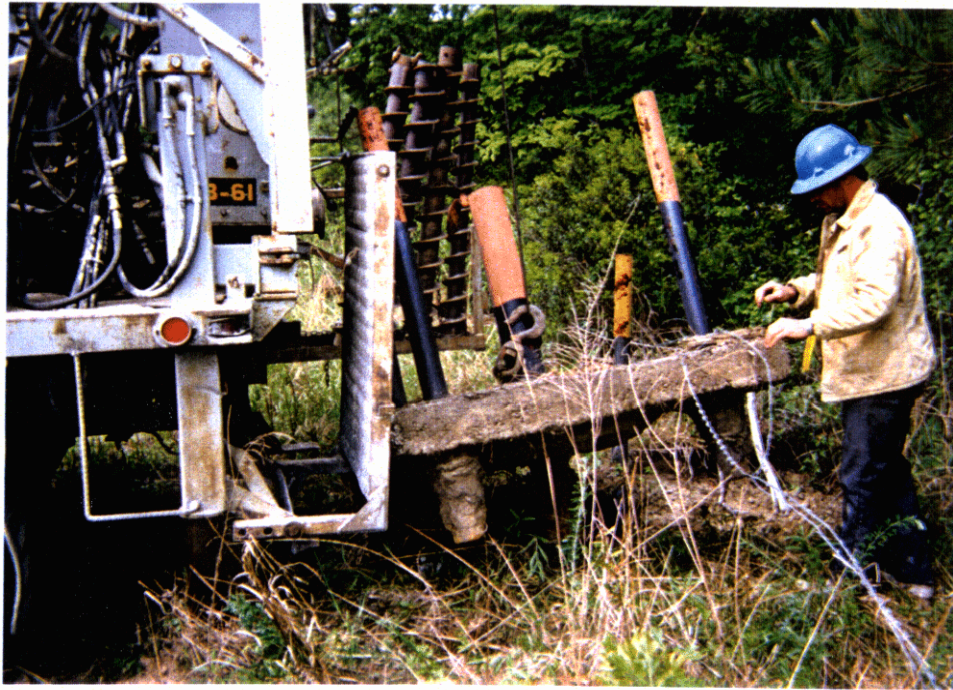
OU7.GW.1994.06: Monitoring well 1-GW05, as shown in this photograph, is in the process of being abandoned. During the RI two monitoring wells were abandoned, 1-GW05 and 28-GW01.

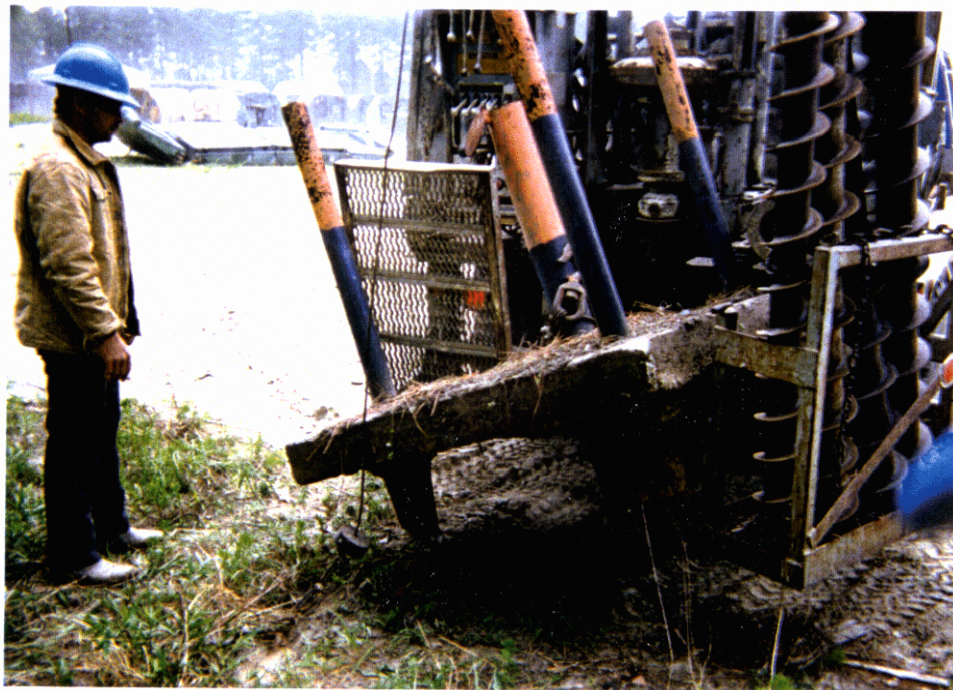
OU7.GW.1994.07: The first step in the abandonment process is the removal of the concrete pad, protective casing, and bollards as shown. Subsequently, the well riser and screen were removed and the borehole was overdrilled and grouted to the surface.

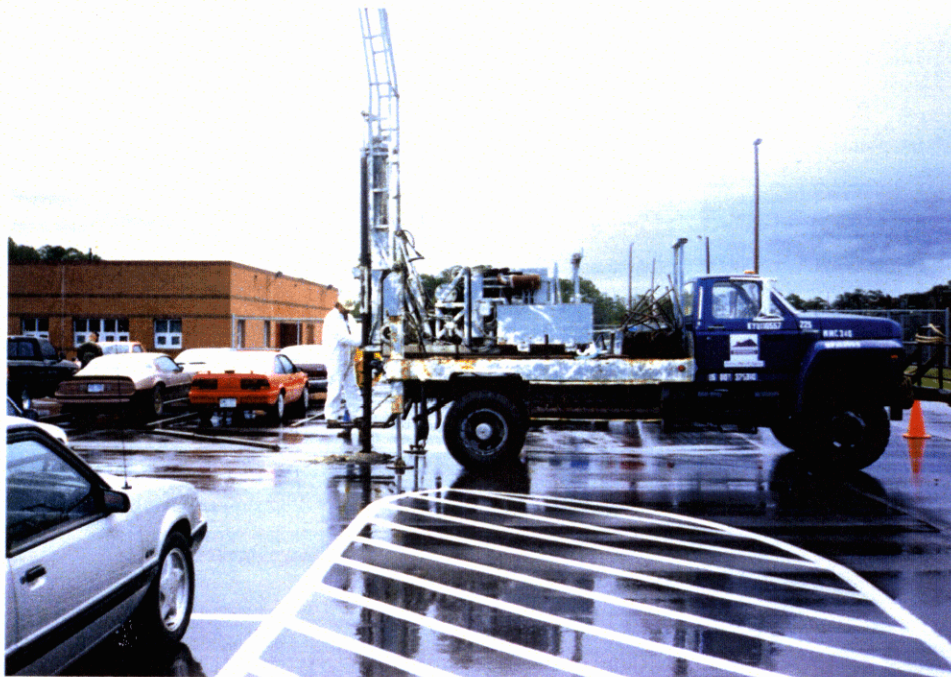
OU7.SL.1994.01: This photograph depicts soil investigation operations at Site 1 (Building FC-134 is pictured in the background). A dedicated auger was used to drill through the asphalt and then another decontaminated auger was used to drill to the desired sampling depth.

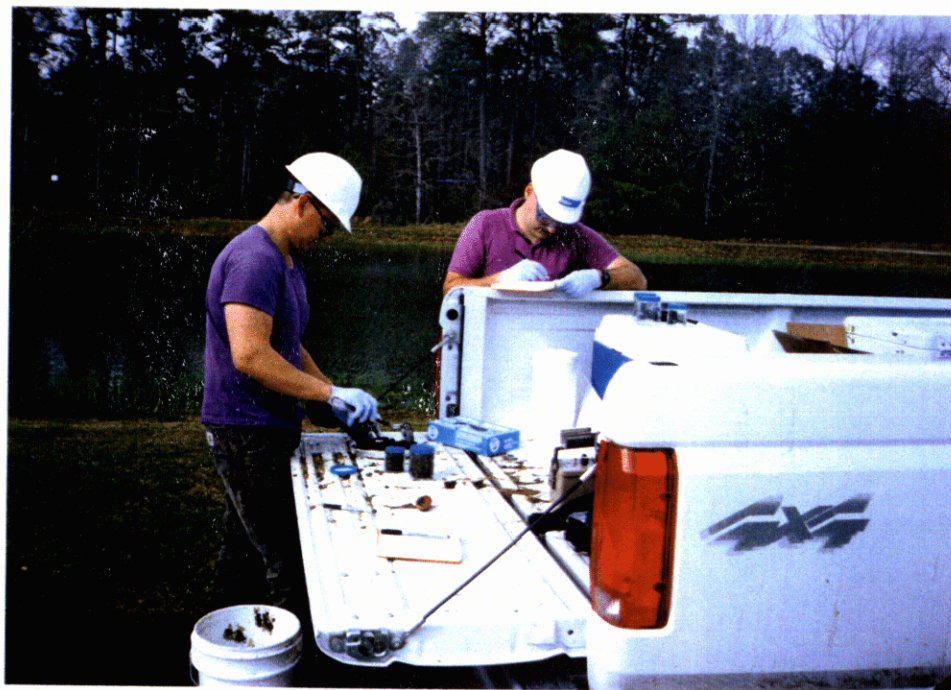
OU7.SL.1994.02: The personnel in this photograph are collecting soil samples at Site 28 adjacent to Orde Pond.

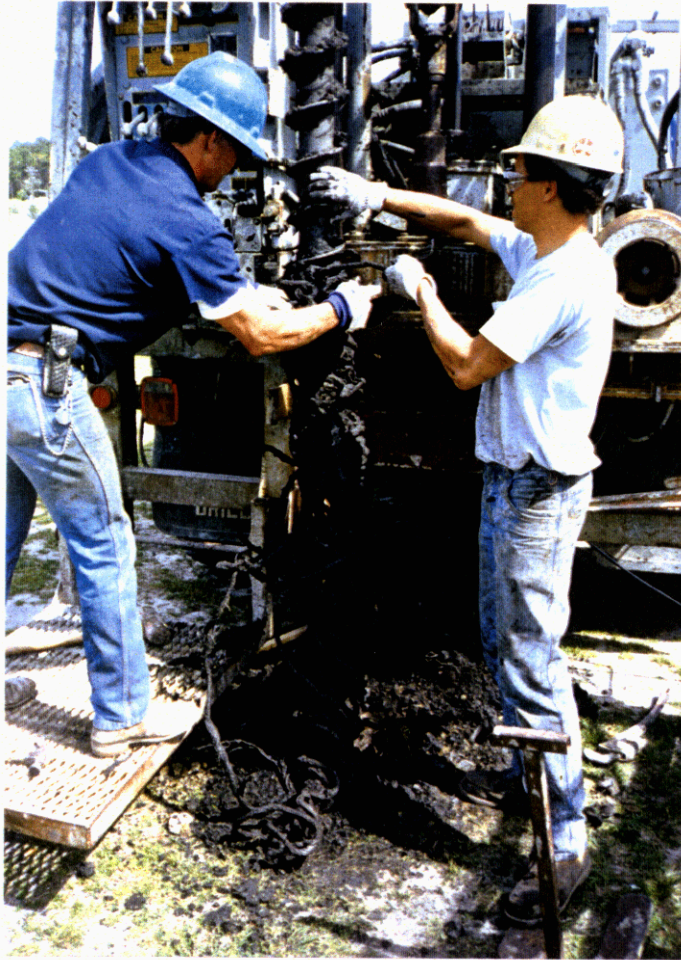
OU7.SL.1994.03: This cabling was unearthed from the western disposal area within Site 28.

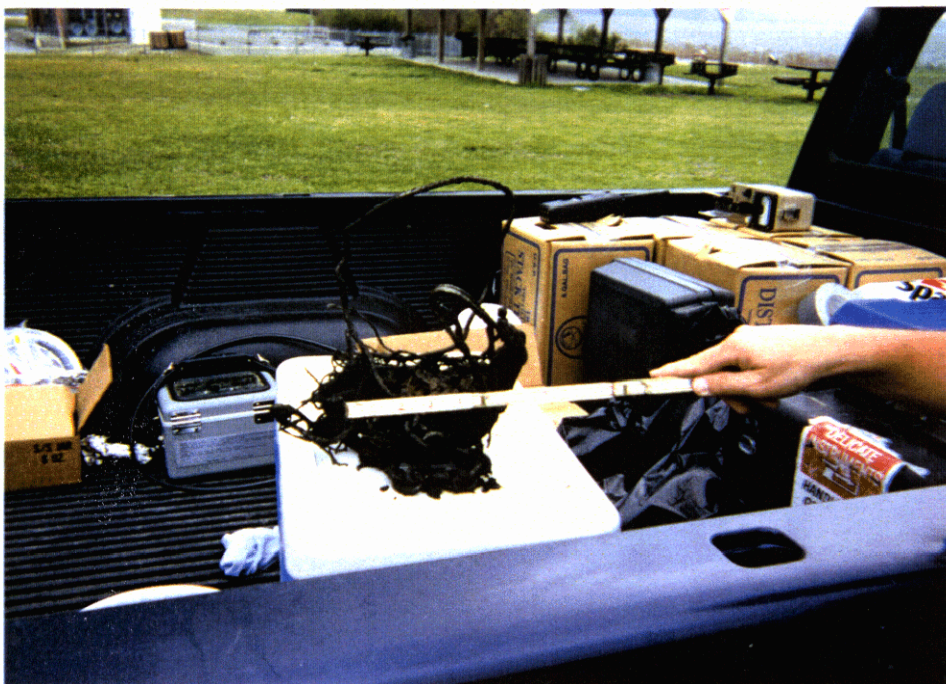
OU7.SL.1994.04: This metallic debris was also unearthed from the western disposal area at Site 28.

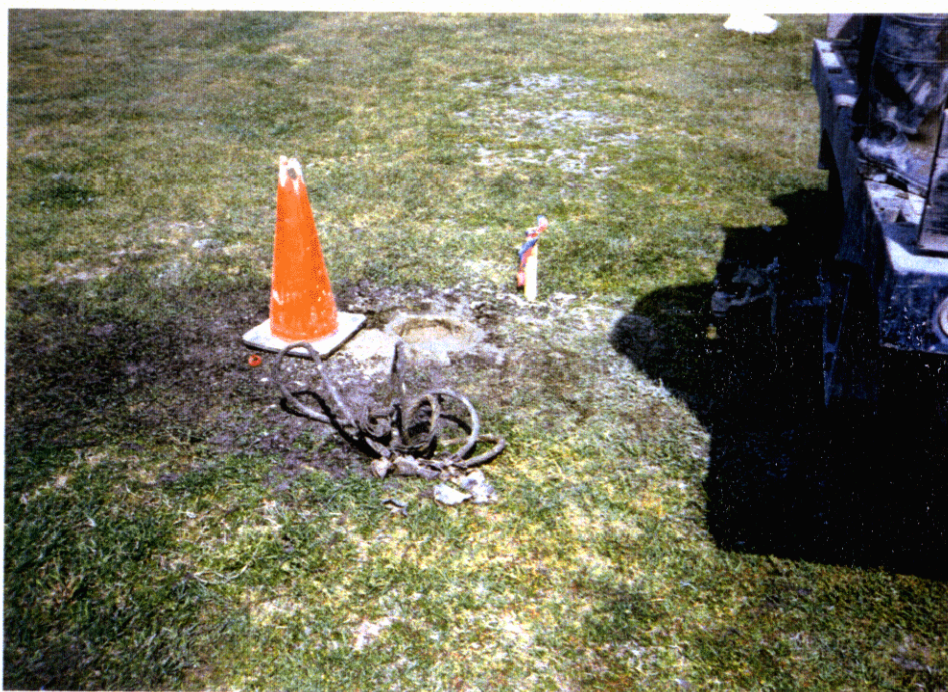
OU7.GW.1994.05: This photograph shows more cable material unearthed from the western disposal area at Site 28.

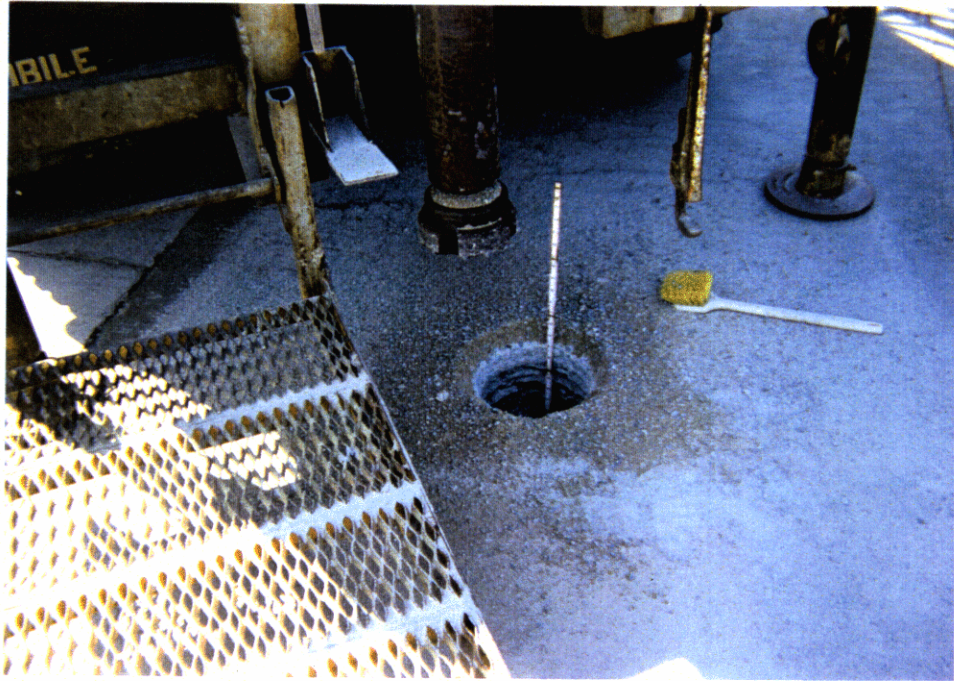
OU7.SL.1994.06: A ten-inch rotary hammer, pictured here, was used to break through the reinforced concrete slab adjacent to Building FC-120 at Site 1. An auger was used to drill to the desired sampling depth.

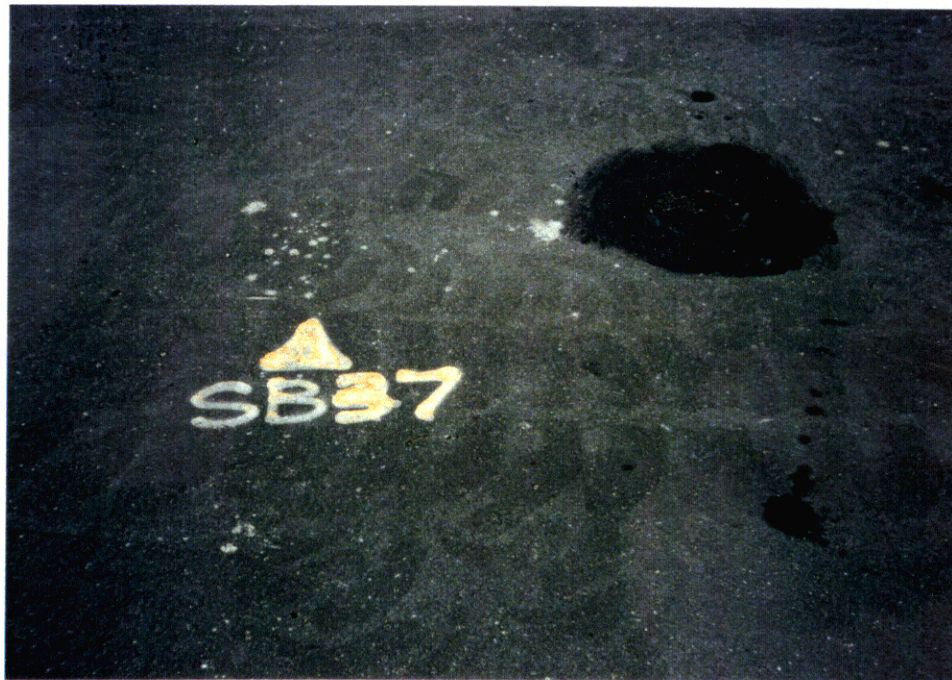
OU7.SL.1994.07: All asphalt and concrete borings were patched with the appropriate patching material.

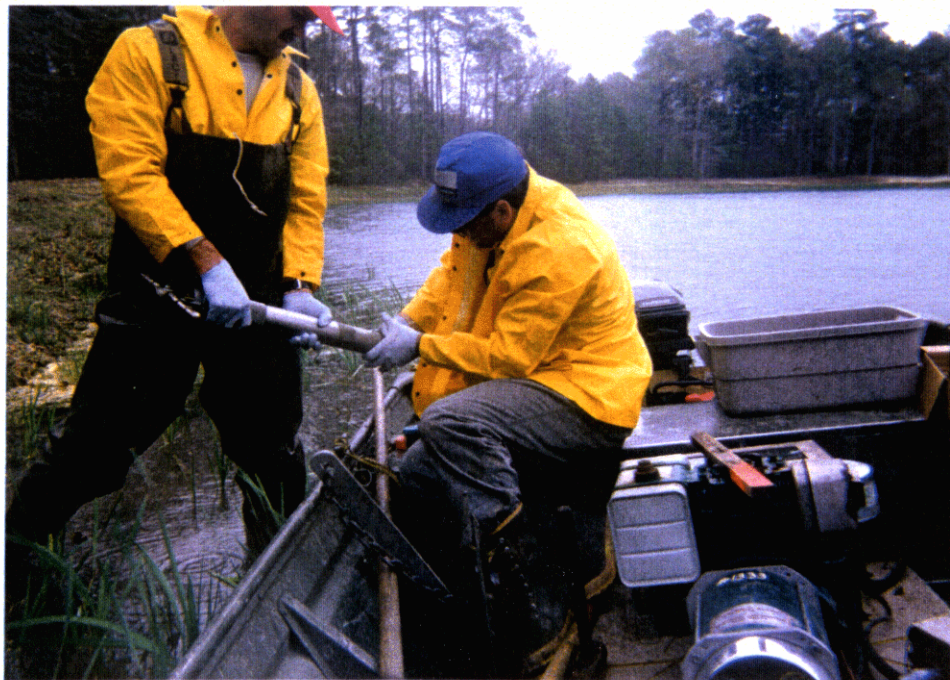
OU7.SD.1994.01: The personnel in this photograph are using a stainless steel, hand-held, coring instrument, fitted with a disposable plastic liner tube and eggshell catcher to collect sediment samples at Orde Pond, Site 28.

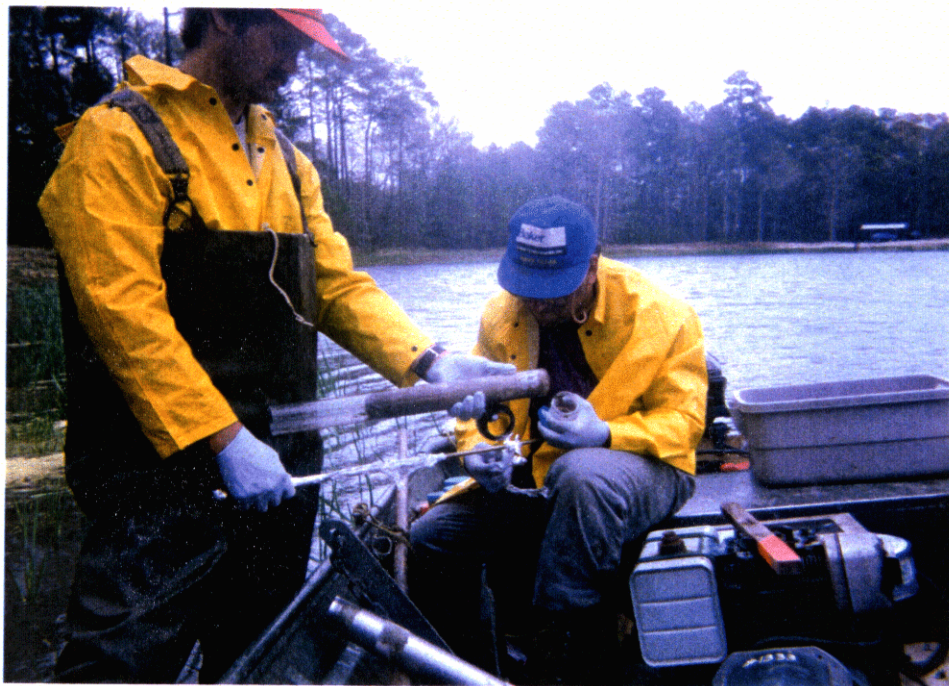
OU7.SD.1994.02: The discrete-depth sediment sample is extruded from the plastic liner tube as shown, using a decontaminated brass extruder.

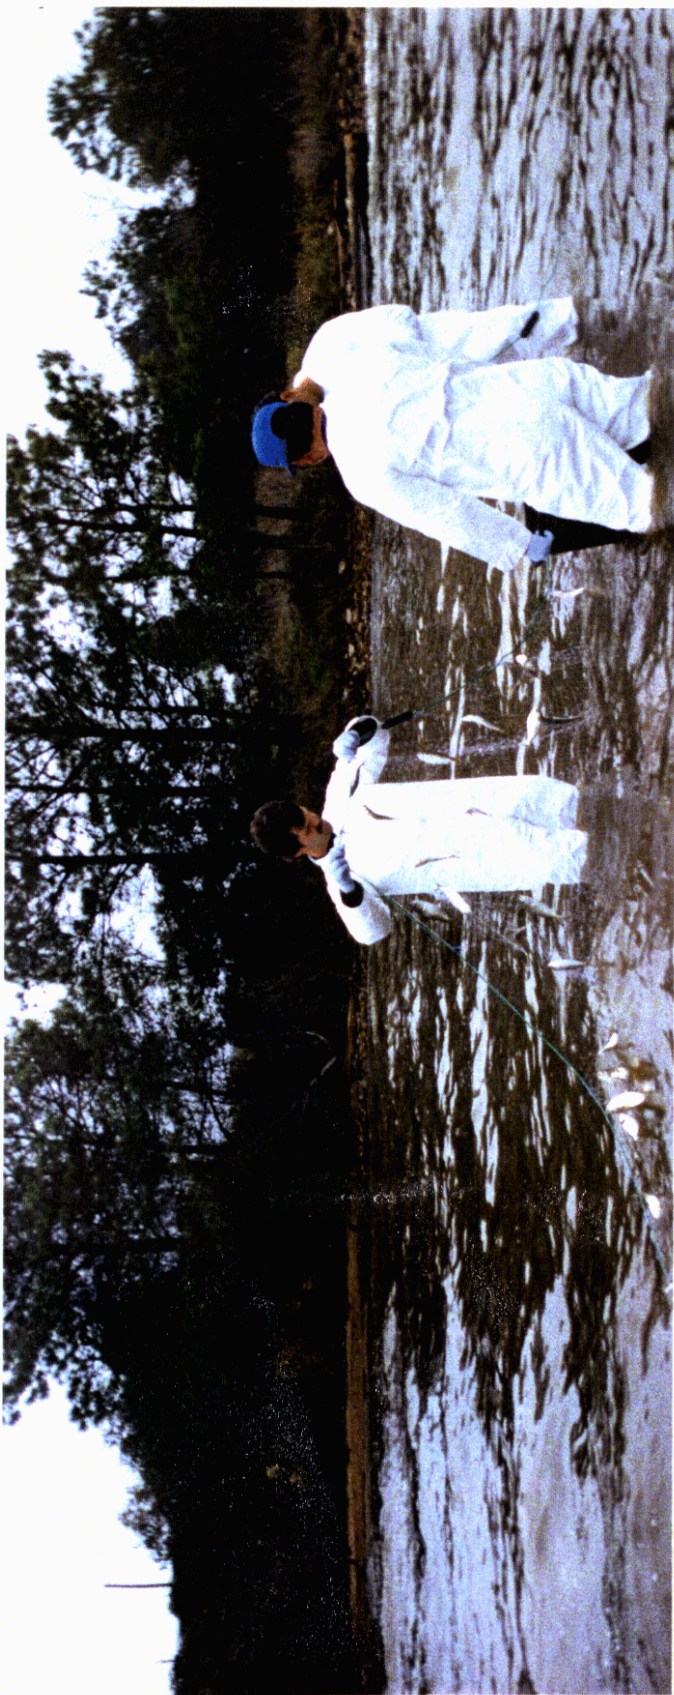
OU7.AQ.1994.01 The personnel in this photograph are using a gill net to collect fish specimens from the New River adjacent to Site 28.
